# the **play inspection** company

## Post Installation Report

Wicksteed Playgrounds

Claxby Village Hall

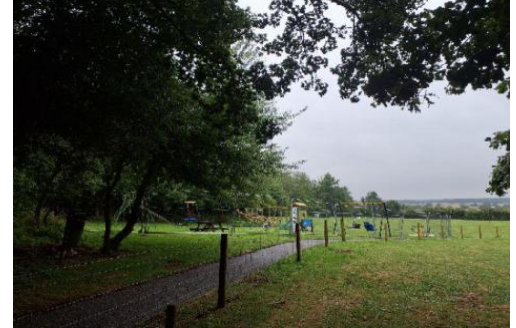
It is recommended that signage, with information including the site address, contact information for maintenance issues and emergency contact details are provided for the facility - Provide in accordance with the recommendations

There are trip hazards at the edges of the pathway - Refer to contractor

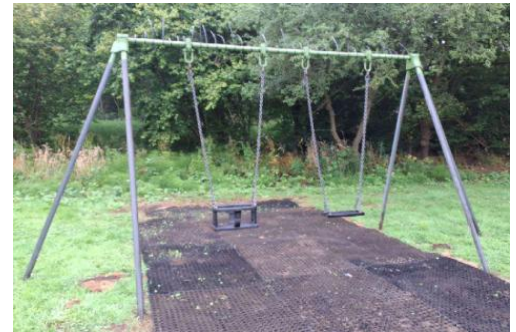
NOTE - This is an existing item of equipment that has had a new seats / chains installed; the item was inspected in full and was found to be satisfactory - no work required -

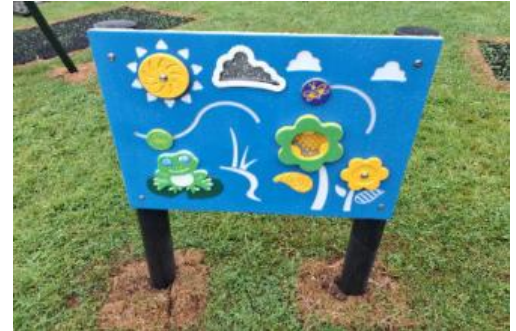
This item is satisfactory - no work required -

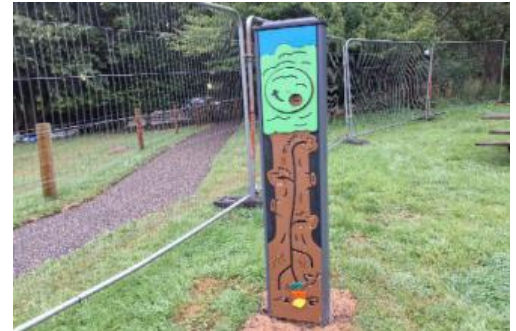
This item is satisfactory - no work required -

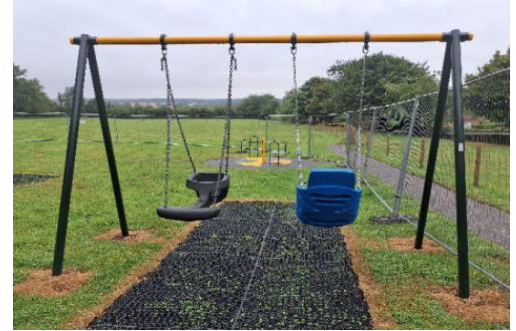
The inclusive seat safety rope comprises of a metal fastening and metal clasp. There is some potential for the rope to not be secured when in use and strike users - Refer to manufacturer guidance

The seats are too close to each other as defined in BS EN 1176 Part 2; this is a low risk failure and no remedial action is required (680mm required / 640mm provided) - No action given the risk assessment

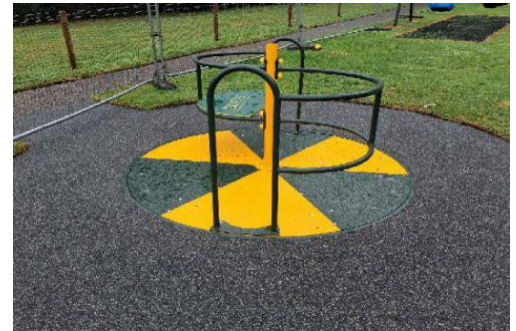
There are trip hazards at the edges of the surface - Refer to contractor

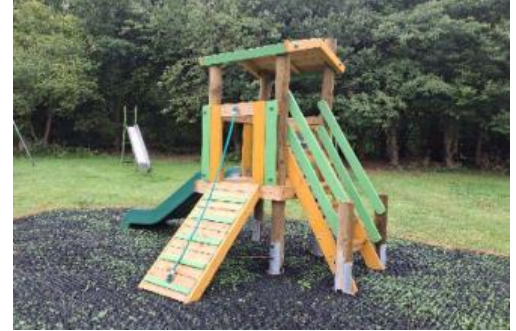
This item is satisfactory - no work required -

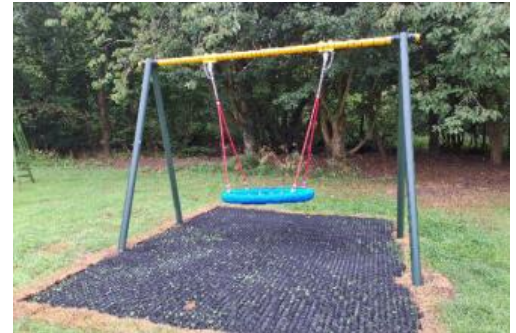
This item is satisfactory - no work required -

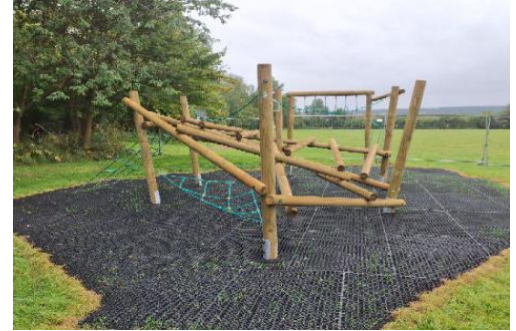
There is/are bolt cap covers missing or damaged on the item - Replace missing or damaged bolt cap covers

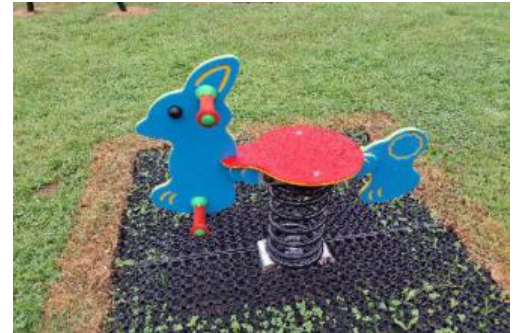
This item is satisfactory - no work required -

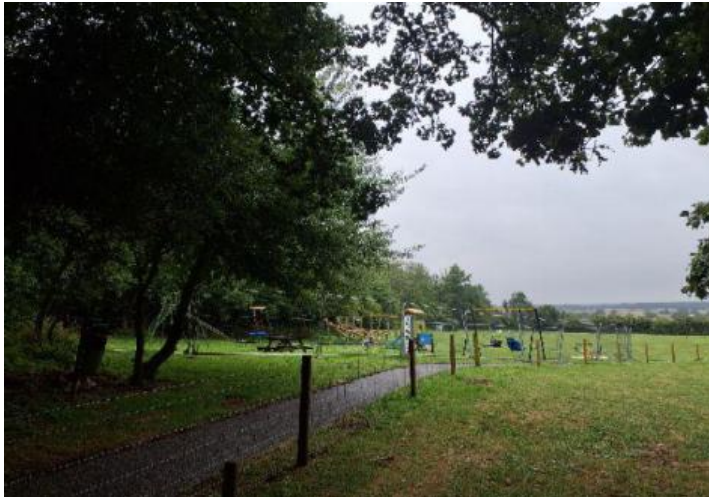
**Finding:** It is recommended that signage, with information including the site address, contact information for maintenance issues and emergency contact details are provided for the facility

**Action:** Provide in accordance with the recommendations

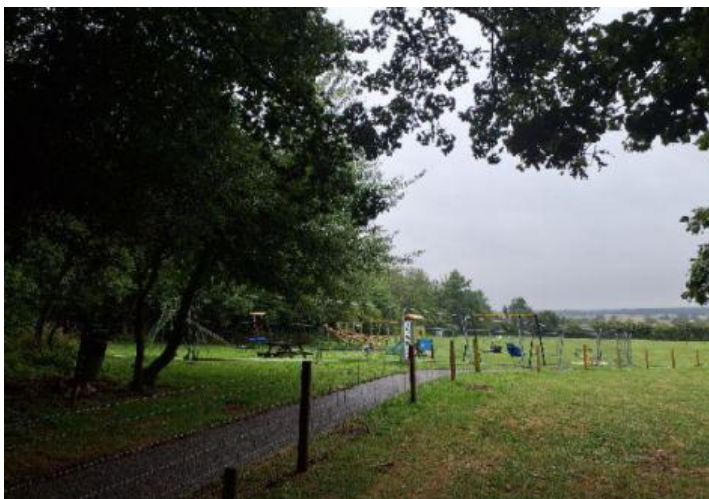
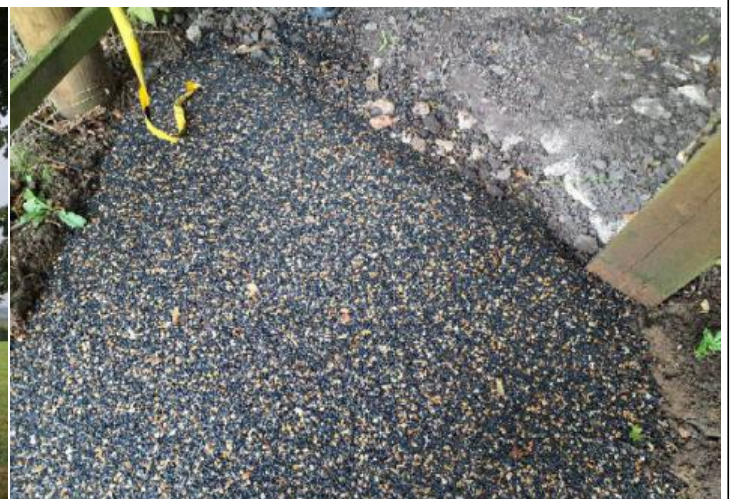
**Finding:** There are trip hazards at the edges of the pathway

**Action:** Refer to contractor

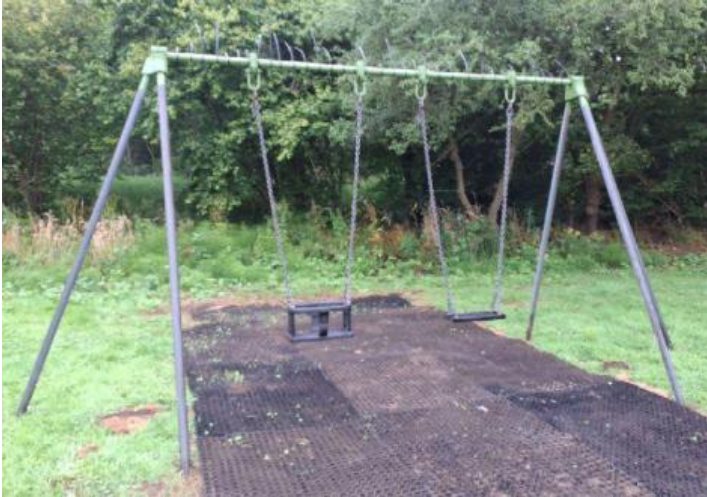
**Finding:** NOTE - This is an existing item of equipment that has had a new seats / chains installed; the item was inspected in full and was found to be satisfactory - no work required

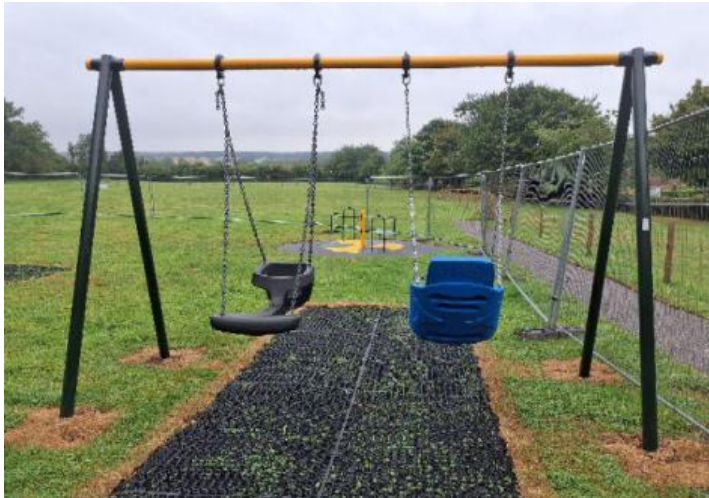
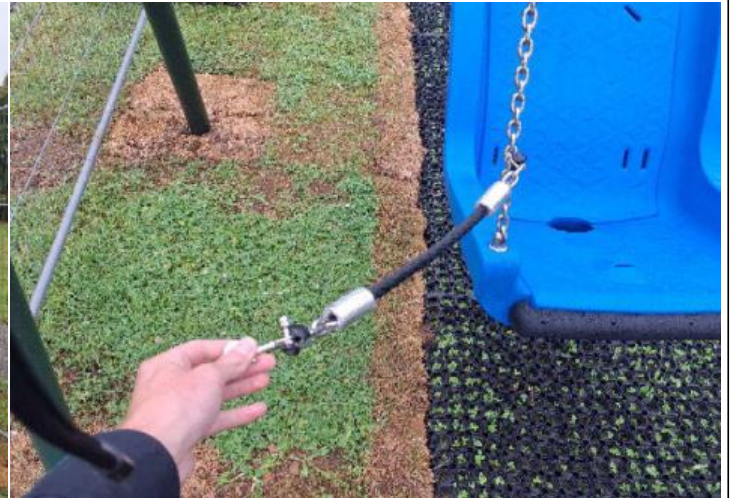
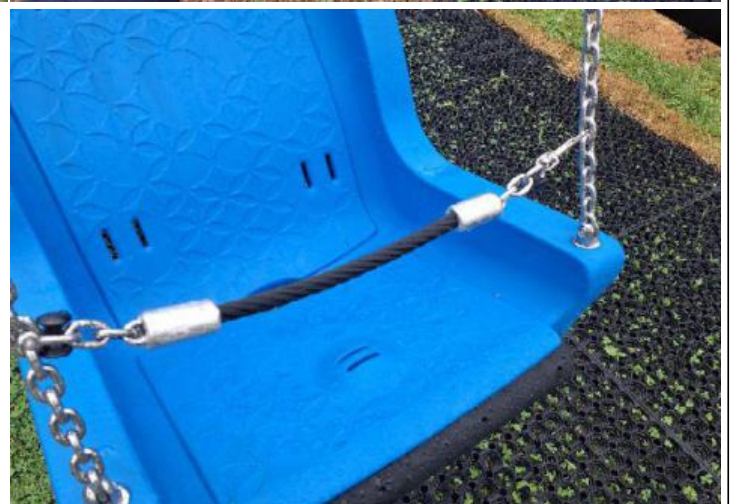
**Finding:** The inclusive seat safety rope comprises of a metal fastening and metal clasp. There is some potential for the rope to not be secured when in use and strike users

**Action:** Refer to manufacturer guidance

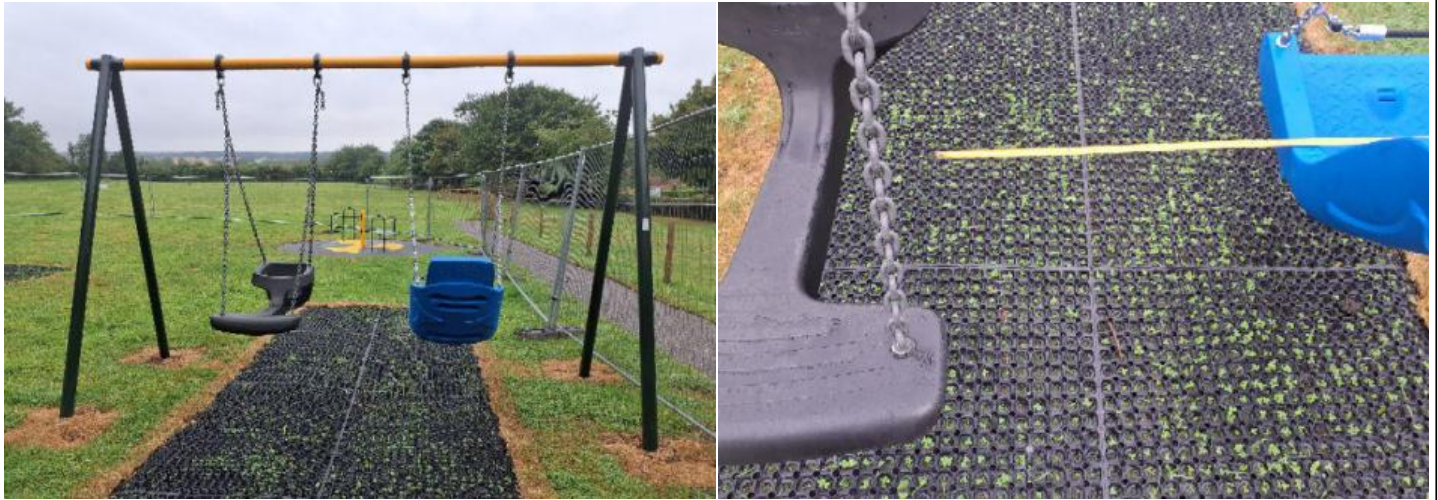
**Finding:** The seats are too close to each other as defined in BS EN 1176 Part 2; this is a low risk failure and no remedial action is required (680mm required / 640mm provided) **Action:** No action given the risk assessment

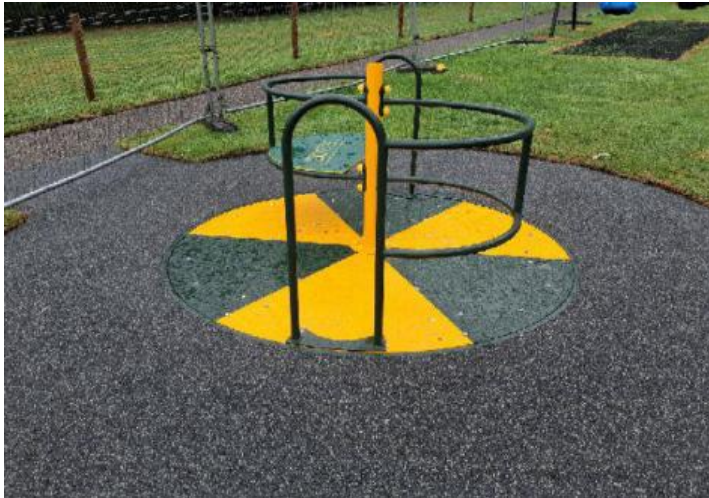
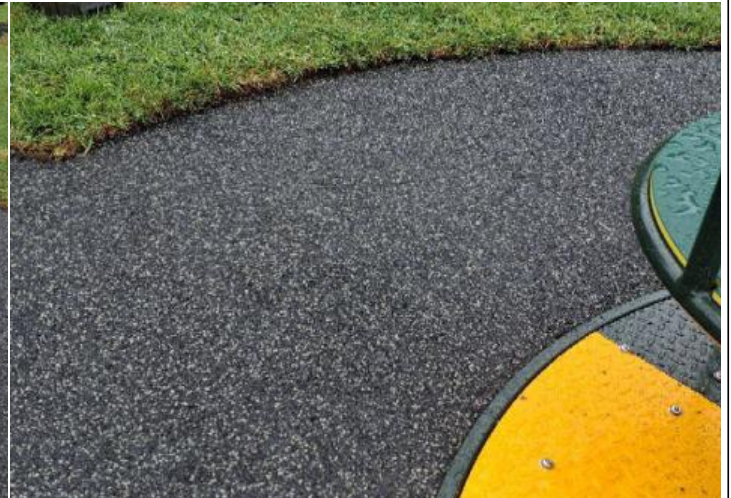
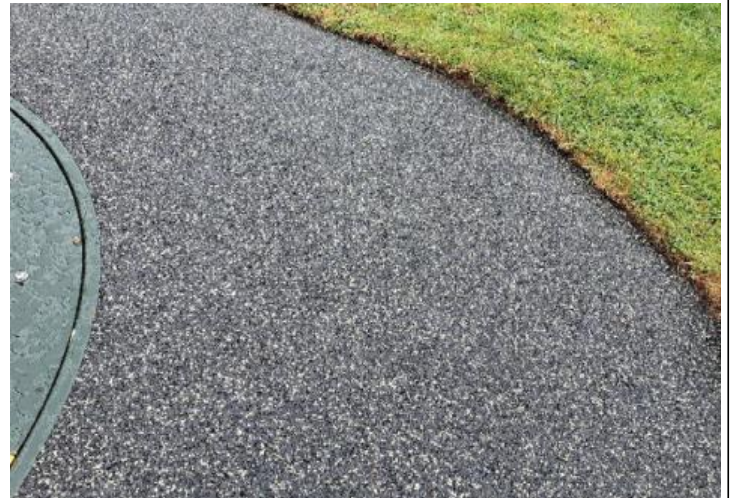
**Finding:** There are trip hazards at the edges of the surface **Action:** Refer to contractor

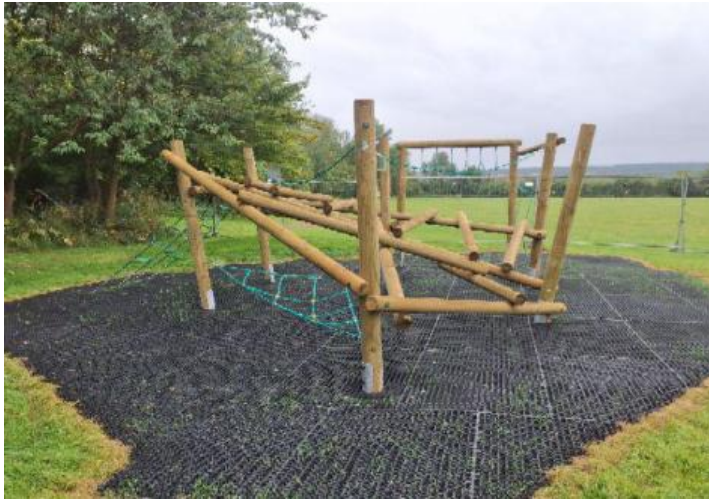
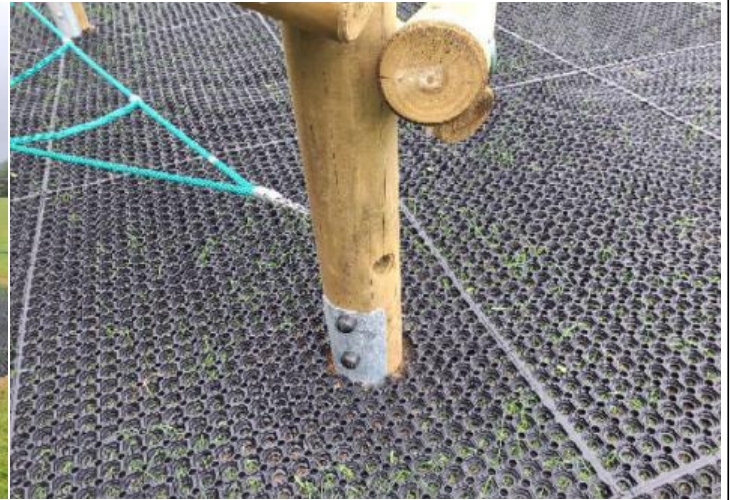
**Finding:** There is/are bolt cap covers missing or damaged on the item

**Action:** Replace missing or damaged bolt cap covers
