# the **play inspection** company

## Post Installation Report

Wicksteed Playgrounds

Claxby Village Hall

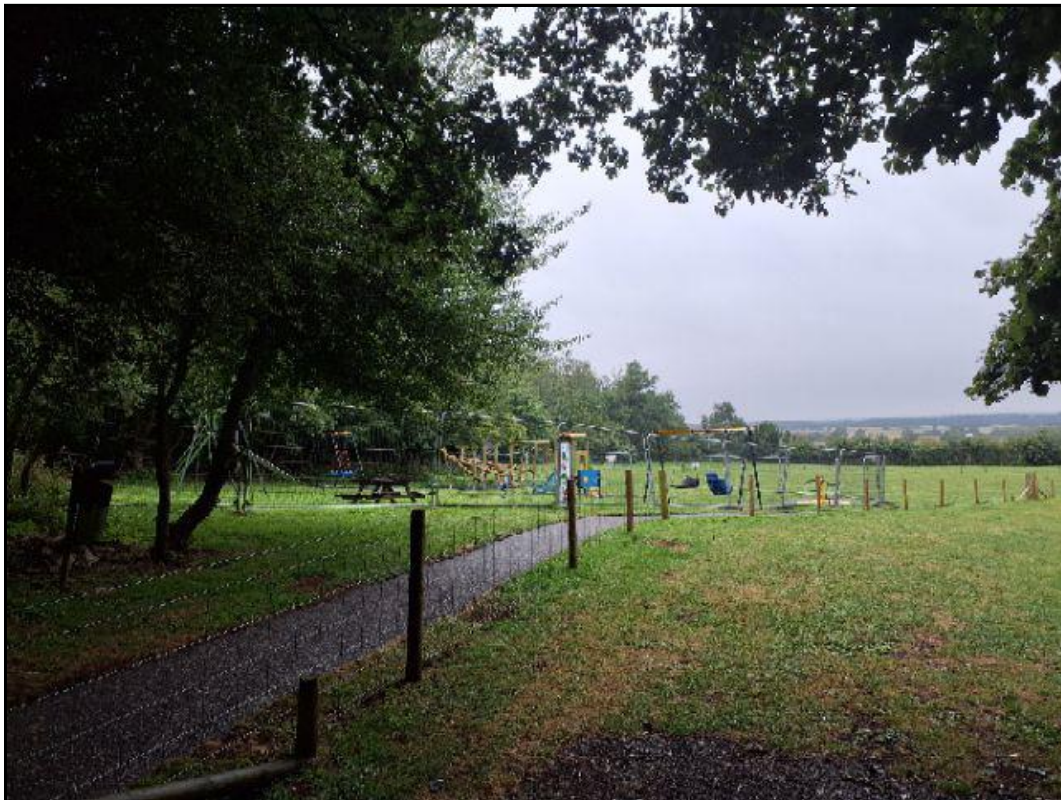
Inspected: 8-August-2024 - 15:53 by John-Aris Hirst (RPII Annual Inspector)

Risk Assessment: 8 Low Risk

The site is partially overlooked by properties in the local community
